RUNWAY OVERRUN DURING LANDING
AMERICAN AIRLINES FLIGHT 1420
MCDONNELL DOUGLAS MD-82, N215AA
LITTLE ROCK, ARKANSAS
JUNE 1, 1999

Aircraft Accident Report

**Runway Overrun During Landing
American Airlines Flight 1420
McDonnell Douglas MD-82, N215AA
Little Rock, Arkansas
June 1, 1999**

**NTSB/AAR-01/02
PB2001-910402
Notation 7195A
Adopted October 23, 2001**

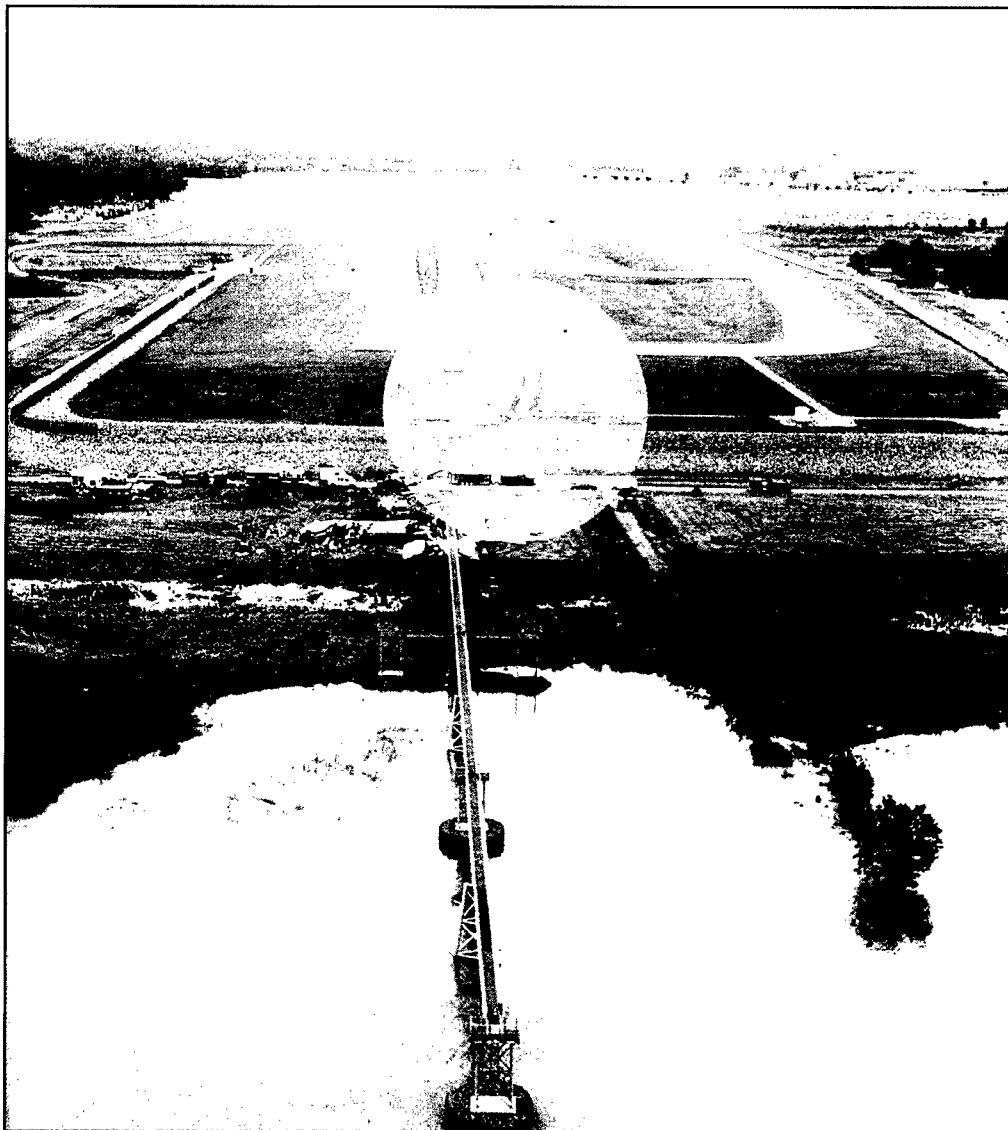
Figure 12. Aerial Photograph of Runway 4R/22L, Airplane Wreckage, and Runway 22L Approach Lighting System

The airplane destroyed several tubes extending outward from the left edge of the runway 4R ILS localizer array, part of a chain link security fence, and approximately 250 feet of the runway 22L approach lighting system support structure and walkway. The damage was estimated at \$325,000.

Figures 12 through 14 are photographs of the airplane wreckage. Figure 12 shows the airplane wreckage, the tire tracks off the end of runway 4R, and the damage to the runway 22L approach lighting system.⁷⁷ Figure 13 shows the airplane wreckage and the runway 22L approach lighting system. Figure 14 shows a closer view of the airplane and the runway 22L approach lighting system. Additional details about the airplane wreckage are presented in sections 1.12.2 through 1.12.4.

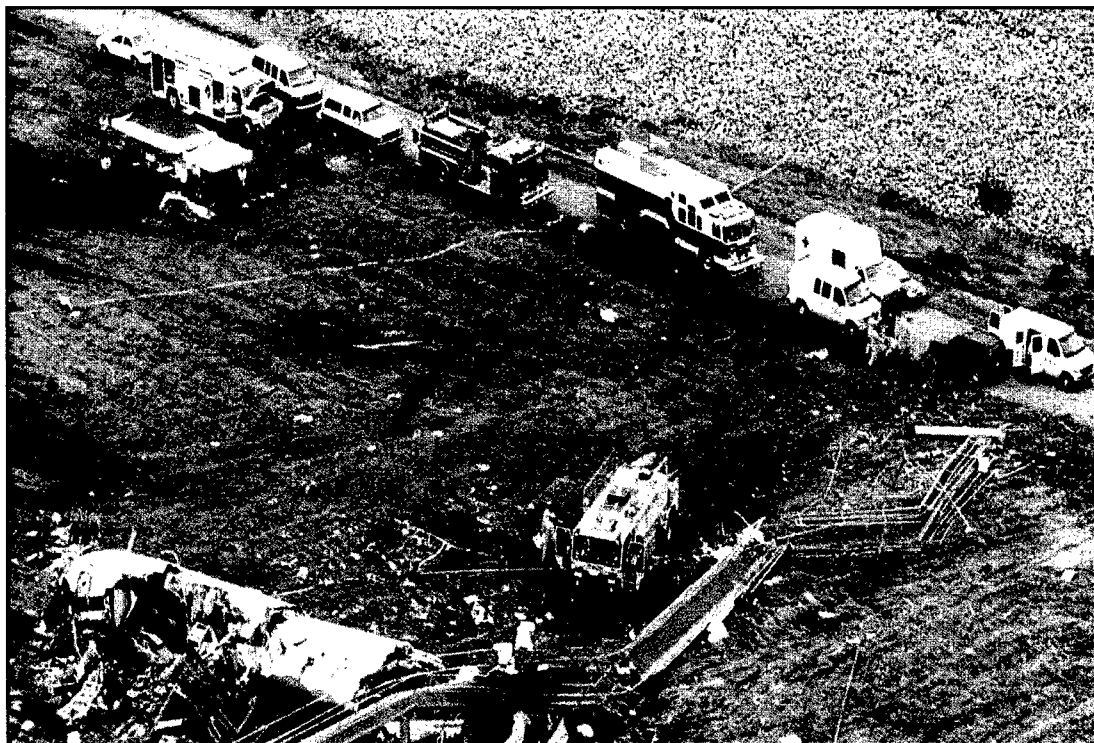
Figure 13. Airplane Wreckage and Runway 22L Approach Lighting System

⁷⁷ The runway 22L approach lighting system is supported by steel columns or platform assemblies that include steel columns. Five steel columns and two platform assemblies were struck by the accident airplane during its overrun. Each of these seven support structures was spaced 50 feet apart along a line that coincided with the centerline of runway 4R/22L. The first support structure was located about 530 feet from the end of the runway, and the seventh was located 830 feet from the end of the runway.

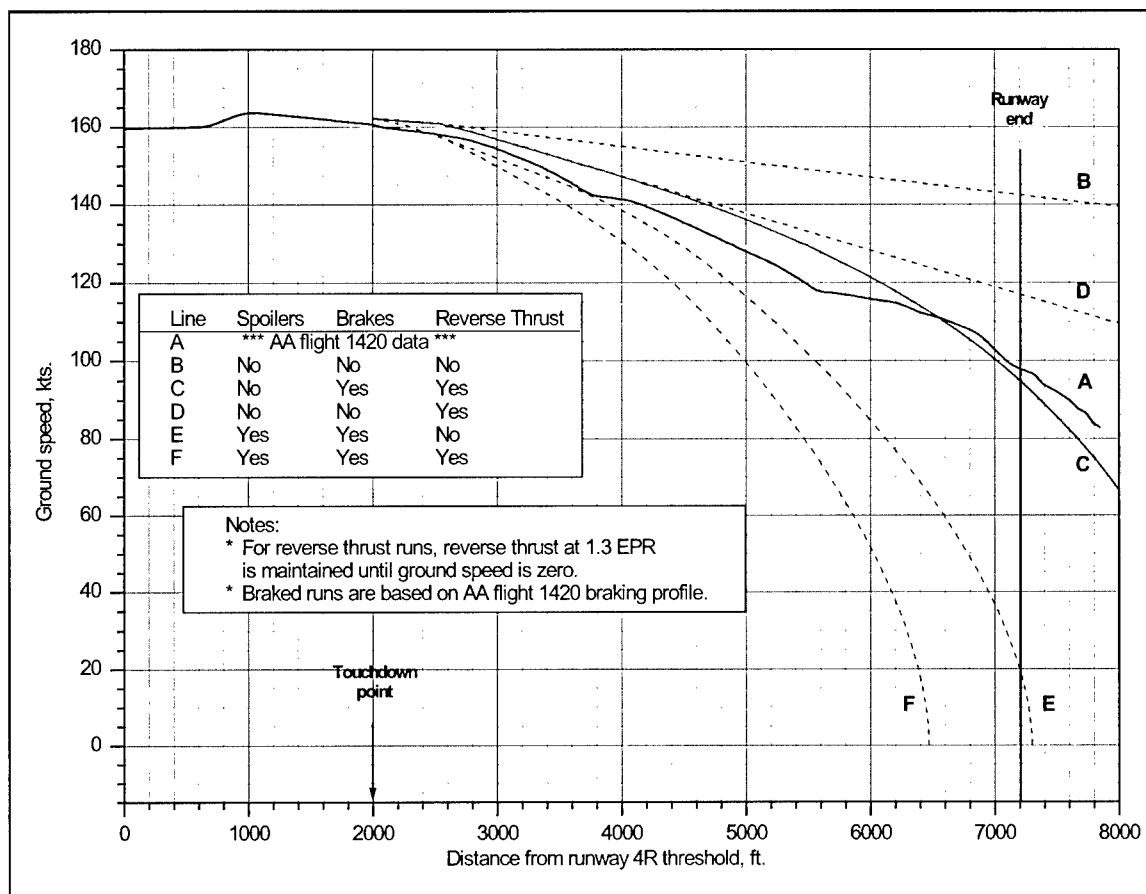
Figure 16. Effects of Spoilers, Brakes, and Reverse Thrust on Stopping Distance

With no braking, spoilers, or reverse thrust, the airplane would depart the runway with a ground speed of about 142 knots, which is 45 knots faster than the flight 1420 airplane. With no spoilers or brakes but with a constant, symmetrical reverse thrust at 1.3 EPR, the airplane would leave the runway at 117 knots, which is 20 knots faster than the flight 1420 airplane. With no spoilers but with 1.3 EPR reverse thrust and the flight

1420 braking profile, the airplane would have departed the runway at 95 knots. This computer run matched the flight 1420 data best and indicated that the accident airplane experienced a braking coefficient of at least 0.21 to 0.23 at speeds between 160 and 140 knots, respectively.⁹⁶ Figure 16 shows the results of the computer runs compared with the flight 1420 profile.

Two additional computer runs demonstrated that proper spoiler deployment is critical to deceleration and stopping distance. Without reverse thrust and with the spoilers deployed and the flight 1420 braking profile, the airplane would depart the runway at 20 knots, which is 75 knots less than the airplane with no spoilers but with reverse thrust and braking. With constant reverse thrust, deployed spoilers, and the flight 1420 braking profile, the airplane could have stopped about 700 feet before the end of the runway.
